TS-PIC-89790  
September 1989

AERIAL PHOTOGRAPHIC ANALYSIS OF THE MADISON MINE COMPLEX

Fredericktown, Missouri

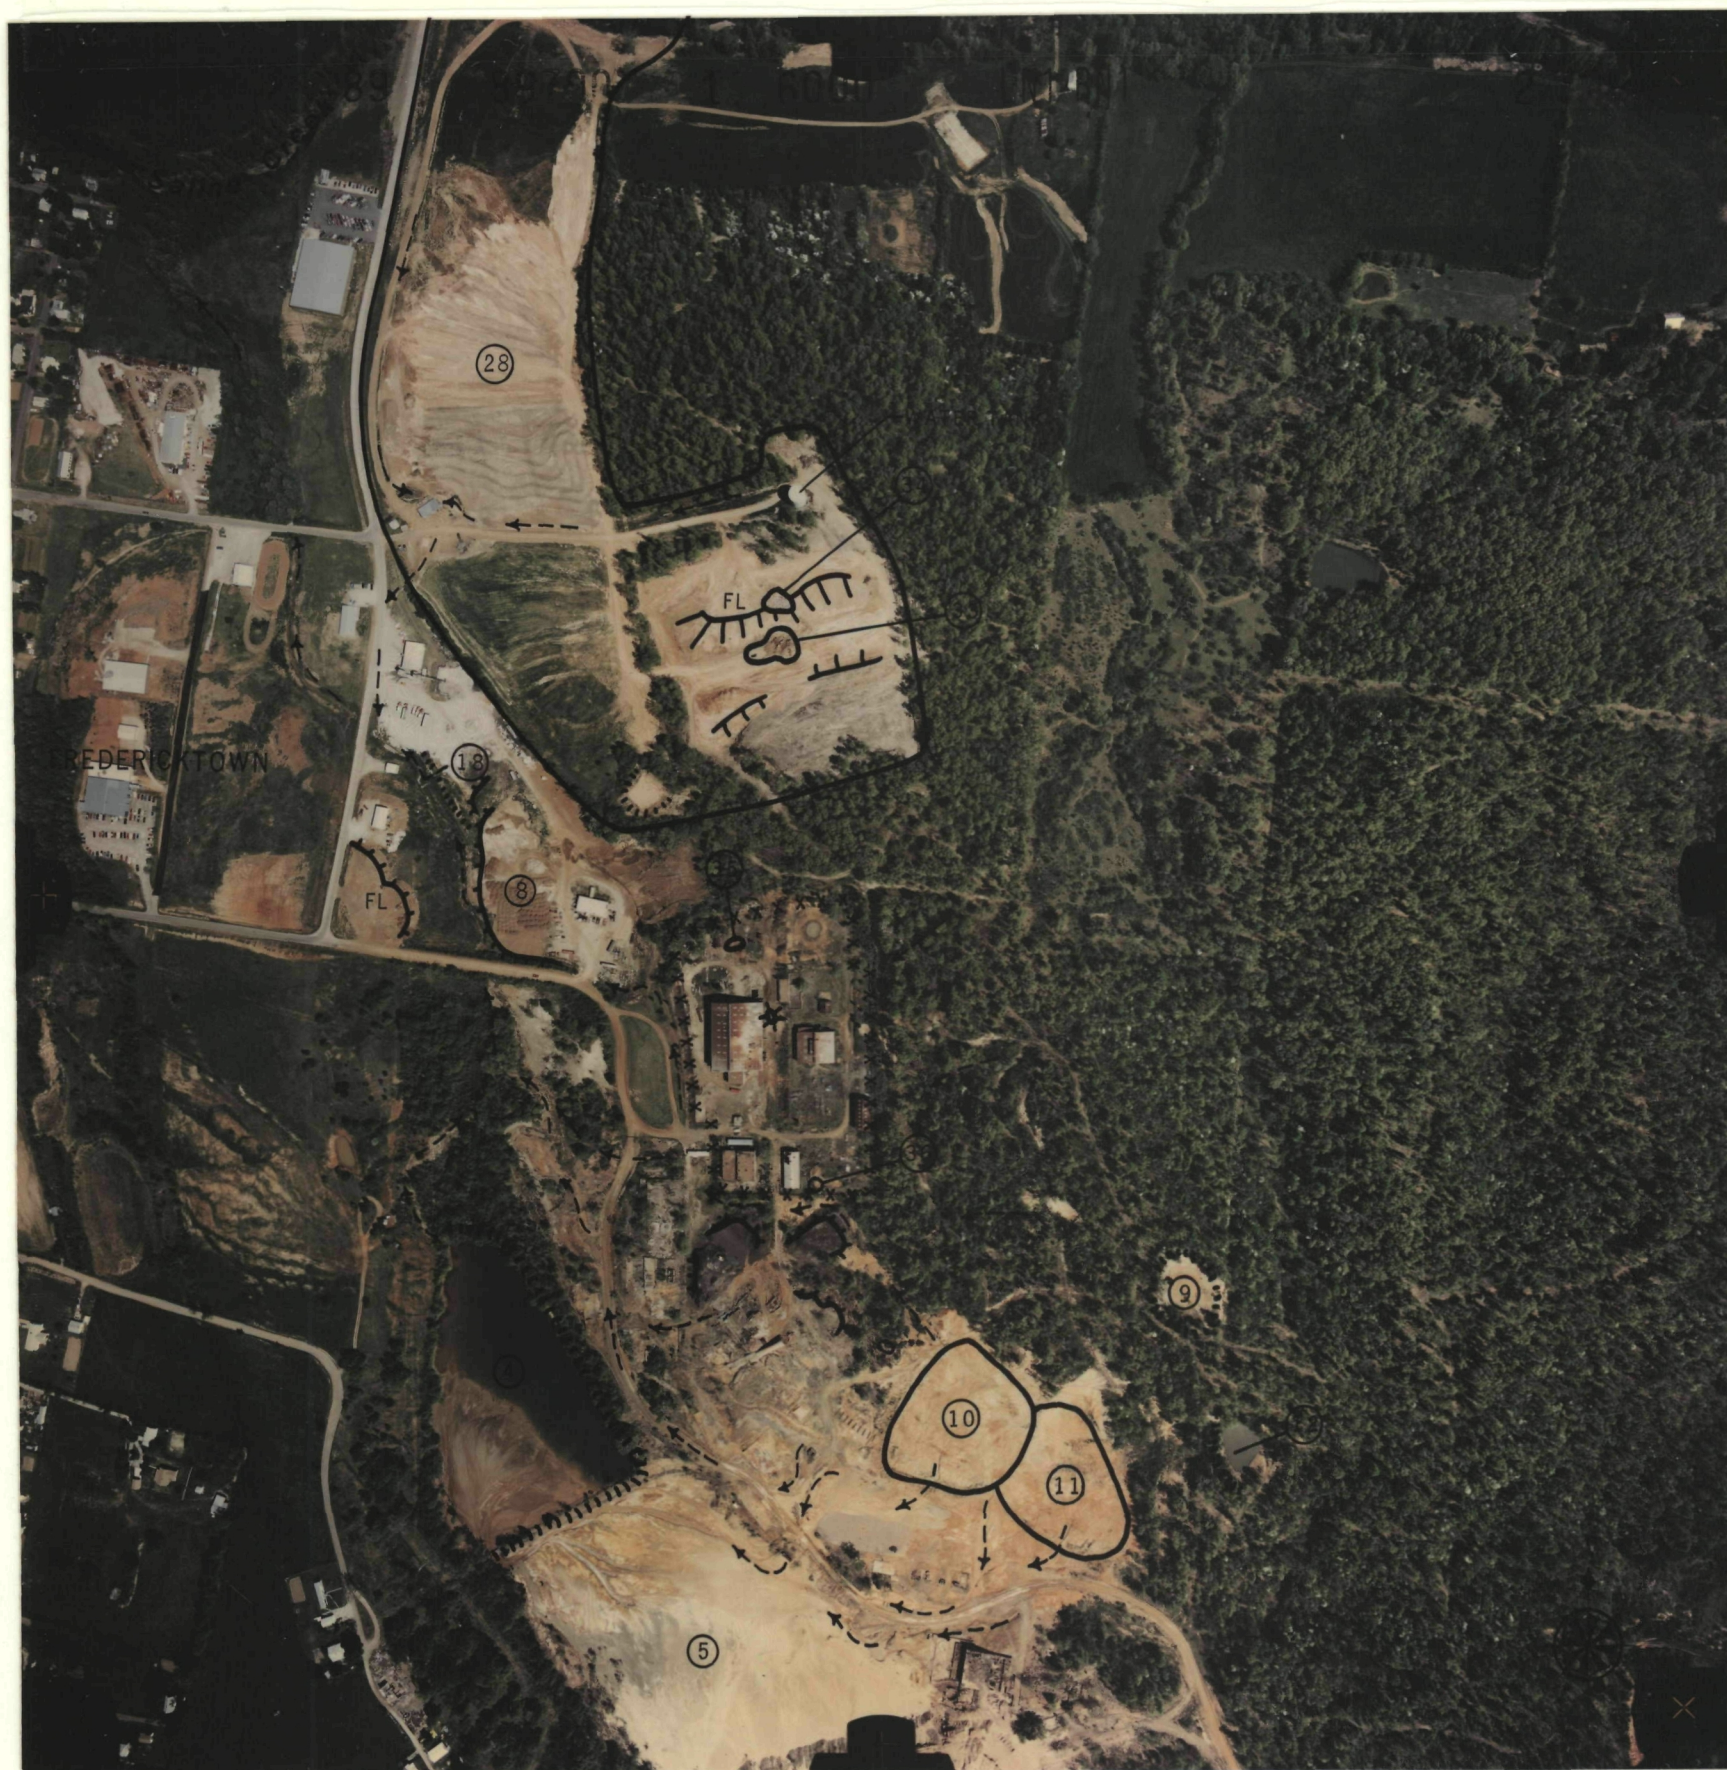
Figure 10. Madison Mine, May 2, 1989. Approximate scale 1:6,000.

No significant changes were observed at the tailings pond (Annotation 4), tailings (Annotation 5) or the ponds located at Annotations 9 and 12 since the photo coverage of April 18, 1984 (Figure 9). The trenches previously located in Annotation 28 have been filled and the south portion of the area revegetated. The hillside east of the revegetation has been cleared and there is a backhoe and dozer digging a pit in the excavation at Annotation 33. Debris has been dumped on top of the fill at Annotation 34. Annotation 18 is the previous location of an impoundment. There is white sediment in the cut that has been made through the containment wall and in the intermittent stream leading north to Saline Creek. The impoundment is partially filled with sand and fill dirt. Annotation 8 is the previous location of an impoundment that has been completely filled. Annotations 35 and 36 show the locations of two newly excavated pits. The containment walls of the ponds previously located at Annotations 10 and 11 have been removed and there are numerous small rills and gullies passing through this area and leading toward the intermittent stream.

There is no significant change noted at the tailings located at Annotation 6 which displays extensive erosion along its northern face and along the southern portion leading into the tailings at Annotation 13. There are five areas around the perimeter of the tailings of Annotation 13 where fill material has been dumped and has now revegetated. The three holding ponds (Annotations 30, 31, and 32) located along the drainage ditch on the eastern side of the facility all contain a greenish colored murky liquid.
